DoD Corrosion Prevention and Control Program

Corrosion/Degradation Monitoring Technology for Composite Materials Used to Extend Building Service Life

Final Report on Project F07-AR03

Michael K. McInerney, Orange S. Marshall, L.D. Stephenson, Ashok Kumar, Lawrence Clark, Chris Olaes, and Vishal Shinde July 2014

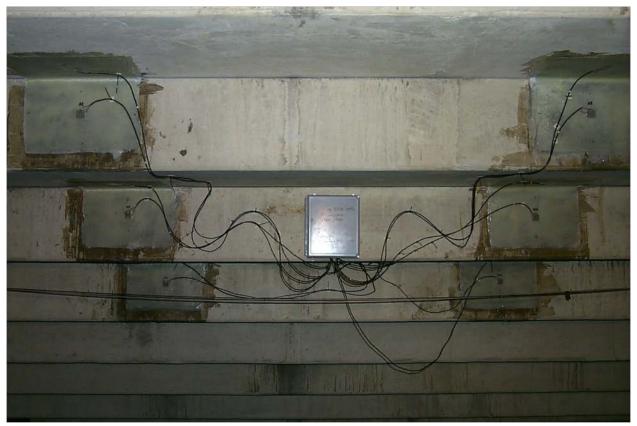
Figure 1. Structural support beams with FRP composite patches and piezoelectric sensors under Michie Stadium.

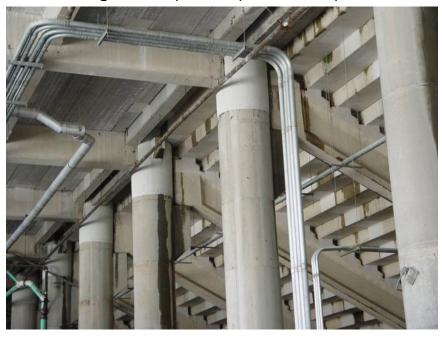
Figure 4. Composite wraps at column tops.

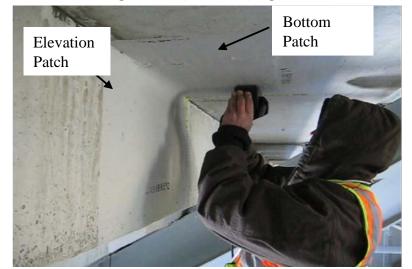
Figure 7. Inspection in progress.

Each inspection was subdivided into two scans: one for the bottom patch and one for the elevation patch. Figure 7 shows the inspection of a bottom patch, with labels indicating both the bottom and elevation patches.
